ERBIL MATERNITY AND PEDIATRIC
HOSPITAL
ERBIL, IRAQ

SUSTAINMENT ASSESSMENT

SIGIR PA-06-094
APRIL 19, 2007

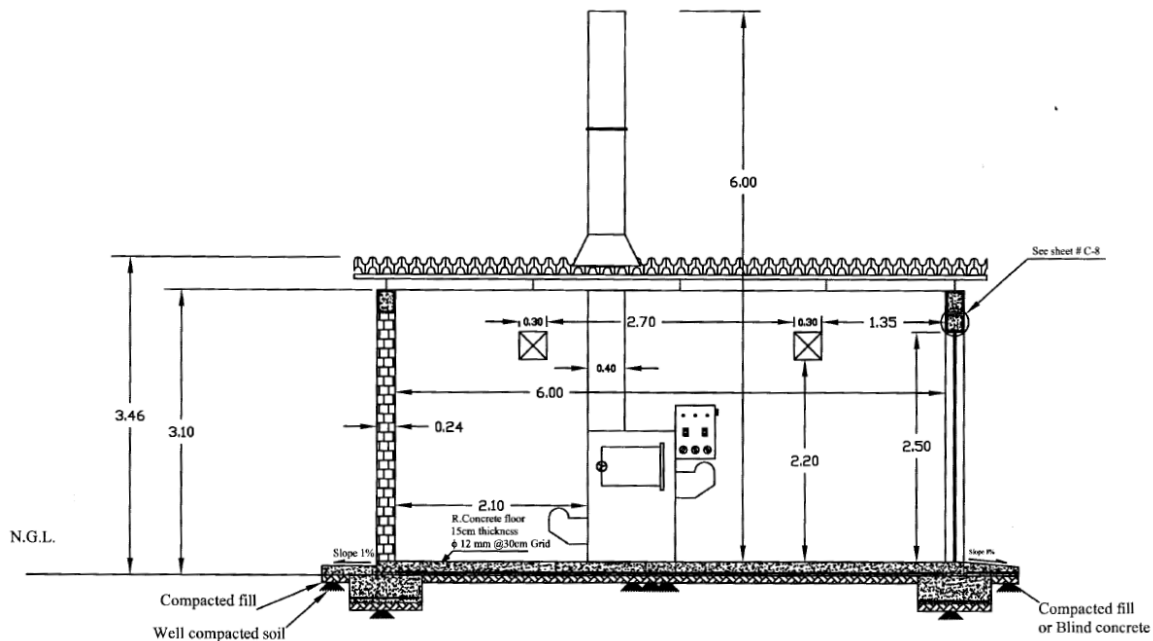
Site Exhibit 1. Incinerator building drawing copied from contractor submittal.

An updated incineration system was part of the SOW for the project. Accordingly, a new diesel incinerator system was successfully built and commissioned to help the hospital better manage waste materials as part of an effective hospital sanitation program. The incinerator system installed by the contractor included a Diesel ATI Type CP 15 incinerator, comprised of a burner, a combustion chamber and a control unit, plus a building approximately 10 feet wide by 20 feet long and designed specifically for incinerator use. Site Exhibit 1 is a drawing of the incinerator and Site Photo 11 is a photo of the completed incinerator building.

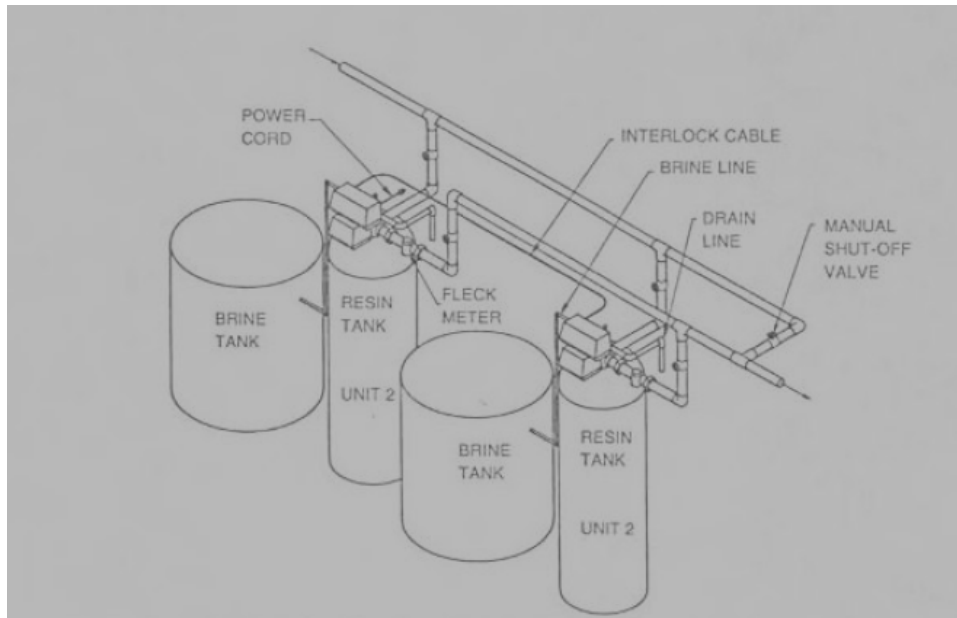
Site Exhibit 2. Diagram shows relative position of the water softening tanks.

The softener system consists of two softeners each capable of providing 24 meters³/hour of conditioned water with a continuous water flow rate with 1 bar pressure drop. Each water softener sub-system consisted of a brine tank and a resin tank. The resin tank exchanges calcium and magnesium ions with sodium ions and the brine tank provides concentrated brine to recharge the resin with sodium ions. Site Exhibit 2 shows a standard brine and resin tank configuration similar to the installation observed.

At the time of inspection, the water softener system appeared not to have been operating for an extended period of time. The tanks contained thick discolored brine that had a pungent odor. Inspectors observed a buildup of salt around the brine tank drain valve. Site Photo 30 shows dried brine around a tank. The salt encircled the base of the tank and encased the drain pipes in a thick mass of salt. Corrosion (rust) coated the valve stem and the tank's drain valve. Oxidation, due to the salt, deteriorated the valve to the degree that serviceability appeared questionable at the time of inspection. If turned, it appeared that the valve's stem could have broken off.
